NEW ALTERNATOR WIRING UPGRADE CONFIGURATION v.3

— John Hoffman

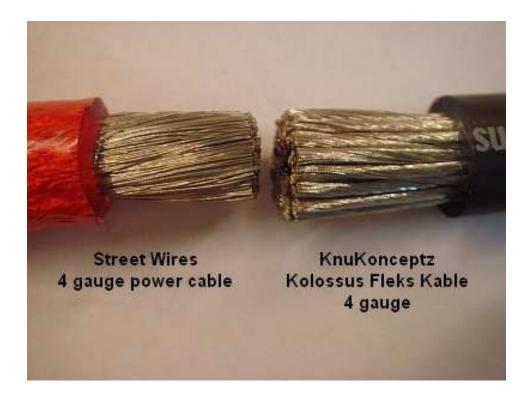
As you can see from this photo, there is much more wire in the cable to the right, even though each is the same gauge.

All of the power and ground wire connections in this wiring modification use **4 gauge Kolossus Fleks Kable** by KnuKonceptz (which electrically, is actually closer to 3 gauge) It is 2068 strands of high-density, fine strand, 100% oxygenfree copper that has been tinned to prevent corrosion. It has a great outer sheath and is very flexible. I highly recommend this cable for this particular modification.

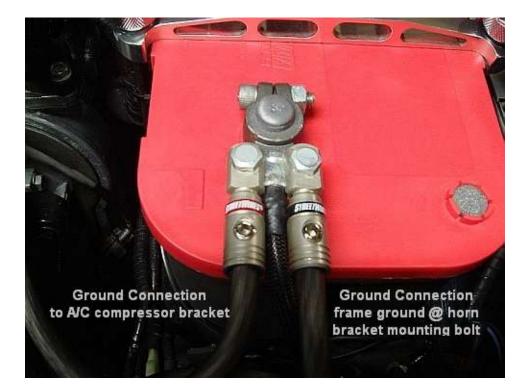
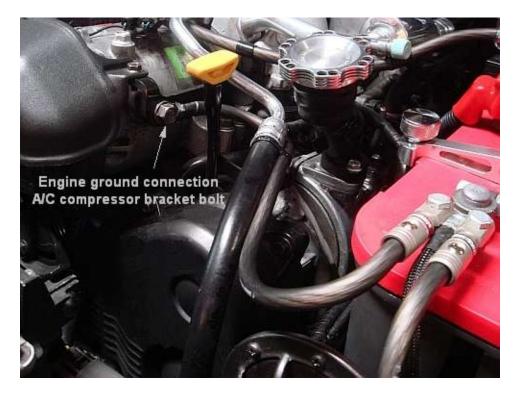
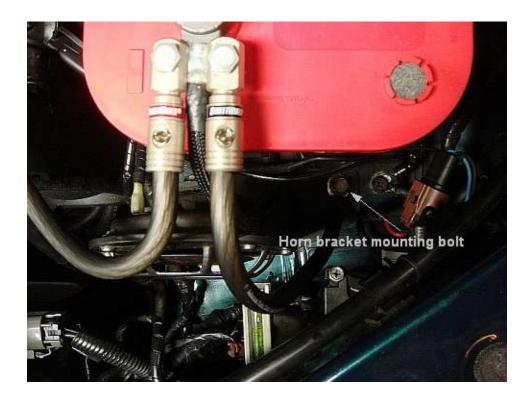
The 4 gauge ground wires from the negative battery terminal to frame ground and engine ground are still being used as in the original configuration, but the smaller, original factory ground wire from the battery to frame ground is now unnecessary and was removed.

In the following photo, the ground cable on the left side is still connected to the bolt of the A/C compressor mounting bracket. The cable on the right is connected to frame ground at the horn bracket mounting bolt or further down and outside the engine bay at the driver's side front tow hook bracket.

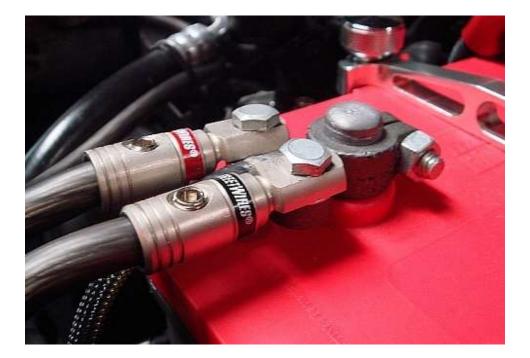
I used a different type of connector, **4 gauge StreetWires Power Rings**, for these wires to increase electrical conductivity, as well as provide a stronger connection. Just one connection at the battery post to totally disconnect power.

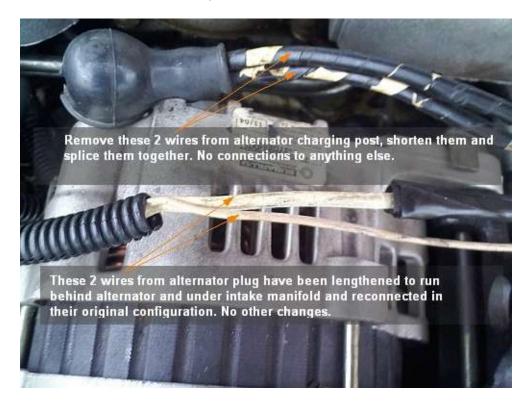
The plastic wiring channel which runs along the top of the engine in front of the intake manifold was opened. Inside the channel you will find two white wires with ring terminals attached to the alternator charging post. You will also find that the 2 white wires from the alternator plug on the side of the alternator runs through this channel as well. One is thicker than the other. More on that later

The following photograph is not of my car. It was taken at to show what the stock configuration of the Subaru SVX looks like before any modifications have been done. This is what is inside that plastic channel.

I removed the two white wires from the alternator post, cut off the ring terminals and shortened them almost 2 feet. One of these wires was factory-spliced into three wires close to the battery. Splice both of the white wires together, using solder or crimp connectors, protected with shrink-wrap tubing and electrical splicing tape.

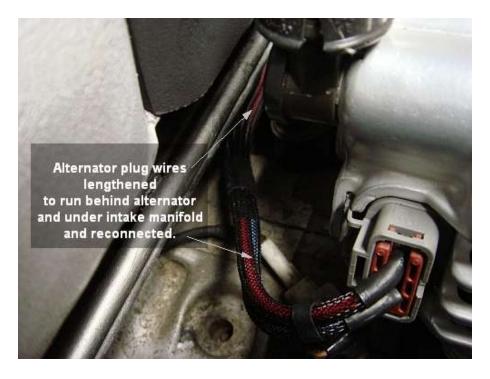
The alternator plug wires were removed from the plastic channel and cut. Be sure to remember which wires are which when you add an additional length of wire to each. You can do this by doing one wire at a time. Using a longer length of wire allows you to run the wires behind the alternator and under the intake manifold and be reconnected at their original position by the battery. These wires were soldered and shrink-wrapped and encased in heat-resistant nylon expandable braided sleeving.

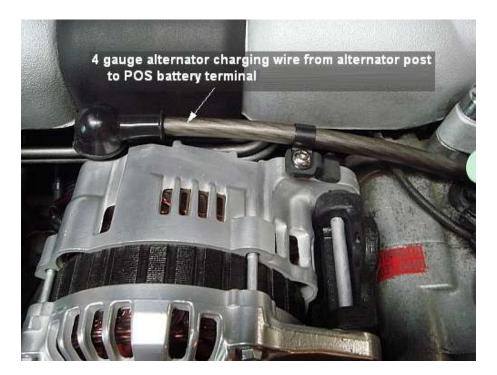
So all that remains is one single 4-gauge power wire, which runs across the top of the engine from the alternator charging lug to the positive battery post,

This single 4 gauge power wire replaces both of the original white wires originally at the alternator; one of which the original charging wire with the fusible link protection. With the two original wires disconnected from the alternator and connected only to each other, the fusible link protection remains in the circuit.

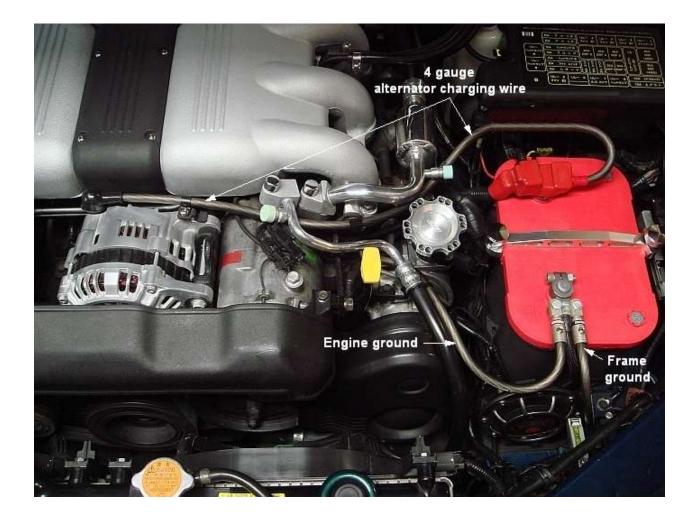
The following photos are circuit overview of the entire wiring modification of the alternator wiring upgrade. It has been designed for a minimum of connections, with maximum transfer of current.

All connectors have been crimped, soldered, and sealed with heat-shrink tubing. Wire splices have been either soldered and shrink-wrapped, or use butt connectors which were crimped and covered with shrink wrap.

Electrical connections use a thin dielectric grease coating for corrosion protection.

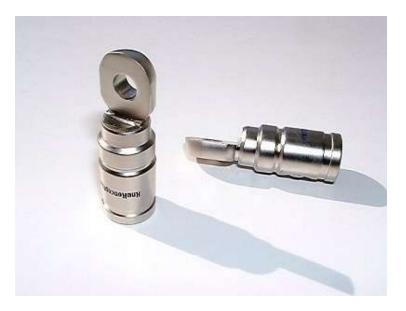
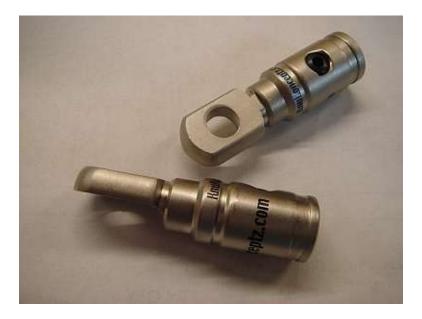
Alternative battery ground wire set-screw terminals by KnuKonceptz can be found on ebay <u>HERE</u> for about **\$10.00 per pair shipped**. Ship them with the power/ ground wires and save.

These are probably as good as the Streetwire PowerLock. I ordered a set with my new cables to compare. The only difference is the size of the Allen set screw. A close of photo is below.

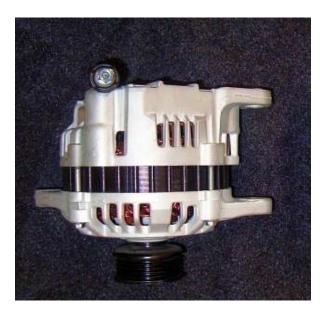
Now the heart of this system HAS to be the 160A high-output alternator, available from <u>Maniac Electric Motors</u>. This is a top-notch rebuild which exceeds the factory unit in every way and is only \$188.00 after your core is returned.
