Tub/Shower Trim

Tub/Shower

Models/Modelos/Modèles T17038, T17138, T17238, T17438,
T17238-H2O & T17438-H2O Series/Series/Seria

Cartridge Summary Reference Sheet

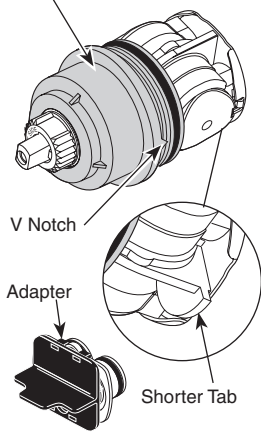
17

Grey Upper Cap

Order RP46463 to Replace Cartridge.

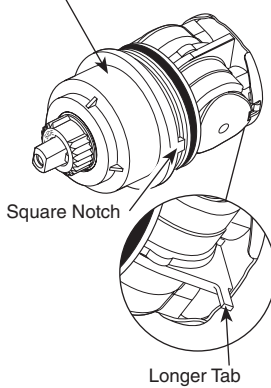
1700

White Upper Cap

Order RP32104 to Replace Cartridge.
