Part # TBF-5 instruction sheets 64-66
Mustang, 62-65 Falcon, and 62-65 Ranchero

TBF-5 uses a performance Teflon lined spherical bearing in place of a rubber bushing. The bearing does not require lubrication because of the Teflon lining. The ball joint is replaceable compared to stock control arms, which if the ball joint goes bad the entire arm must be replaced.

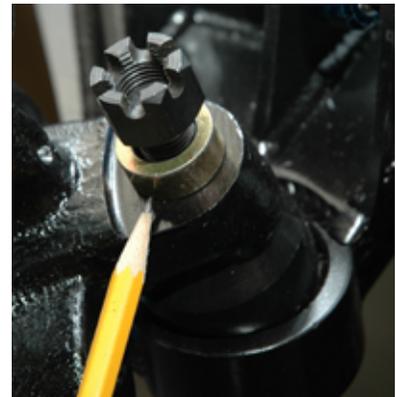
4. The ball joint installed in the lower control arm has a gold spacer. The spacer installs on top of the spindle and acts as a spacer. See photo.
5. Install the lower arm through the spindle. Make sure the ball joint boot is on the ball joint. Once the ball joint is through the spindle install the gold spacer supplied in the kit. Next install the ball joint nut.
