Troubleshooting for D45RE15, D45RE3, D45RE8 & D45RE3000

D45 Series Piston “Fit” Test - Part 1

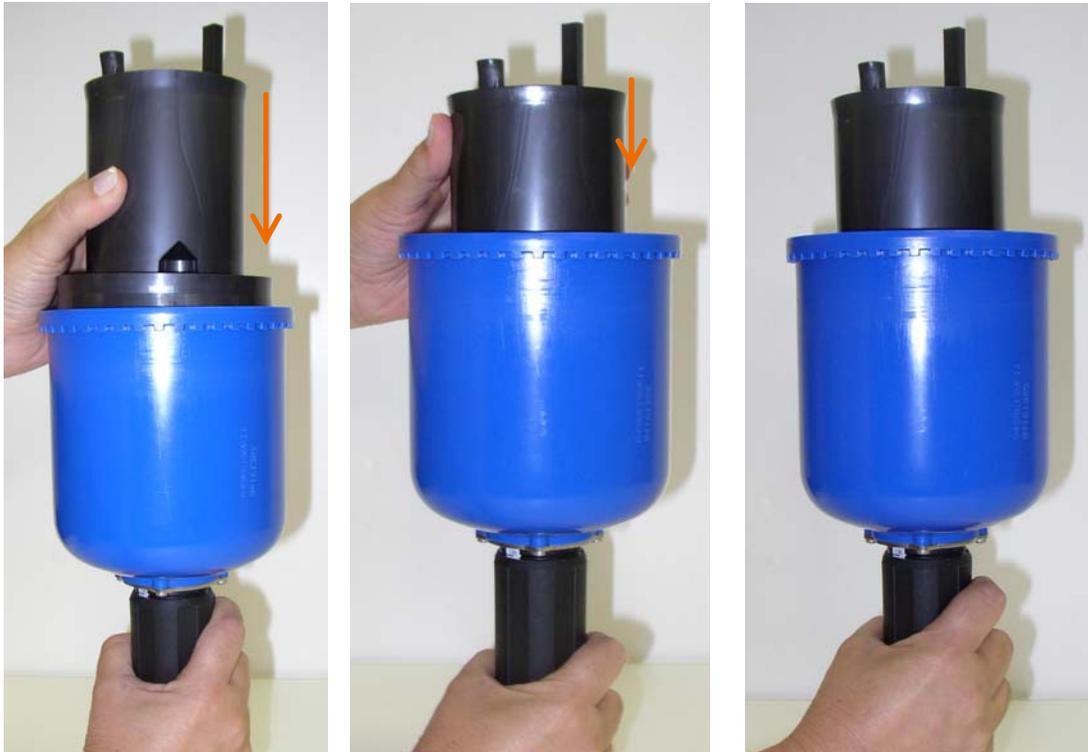
Note: Remove plunger prior to doing this test so it will not interfere.

Insert piston into the lower housing half way down, hold the lower part of the unit from the lower housing, then let go of the piston. The piston should be snug in the lower housing and should not slide down, if it does, the piston shell needs to be replaced. Also inspect the inside of the lower housing and look for deep vertical scratches, if this is the case, the lower housing needs to be replaced.

| Symptom | Cause | Solution |
|--|--|--|
| | Worn piston shells, bell housing or body | Do piston "fit" test (see instructions). Replace piston shells, body and bell housing as necessary. Make sure your installation has a 200 mesh filter before the Dosatron. |
| | Scratched/scored piston shells, bell housing and/or body | Do piston "fit" test (see instructions). replace piston shells, and housing as necessary. Make sure your installation has a 200 mesh filter before the Dosatron. |

| Symptom | Cause | Solution |
|---|--|--|
| | Worn piston shell and/or housing | Do piston "fit" test (see instructions). If necessary replace piston shell, and/or housing. Make sure your installation has a 200 mesh filter before the dispenser. |
| Under injection | Worn or scratched piston shell and/or housing | Do piston "fit" test (see instructions). If necessary replace piston shell and/or housing. Make sure the installation has a 200 mesh filter before the dispenser. |

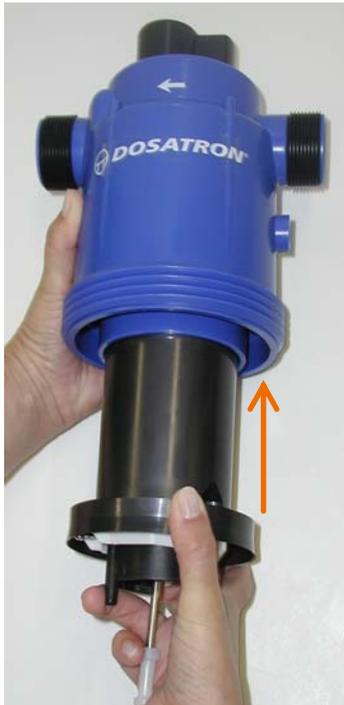
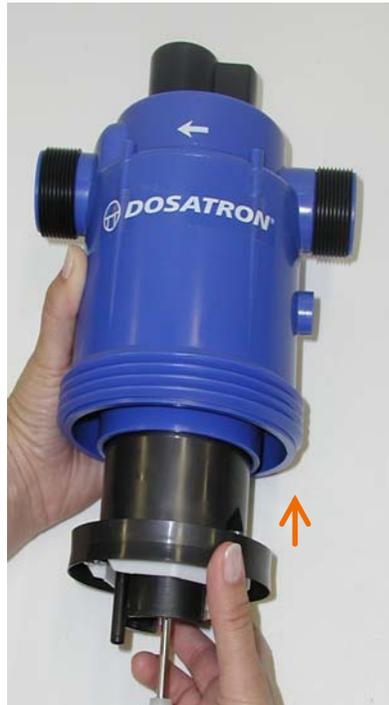
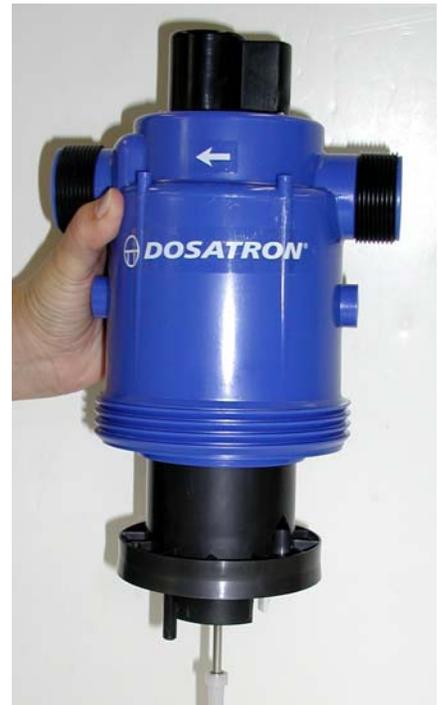
D45 Series Piston “Fit” Test - Part 2

Insert piston into the upper half way up, hold the upper housing of the unit with the piston facing down, then let go of the piston. The piston should be snug in the upper housing and the piston should not fall out, if it does, the piston shell needs to be replaced. Also inspect the inside of the upper housing and look for deep vertical scratches, if this is the case, the upper housing needs to be replaced.

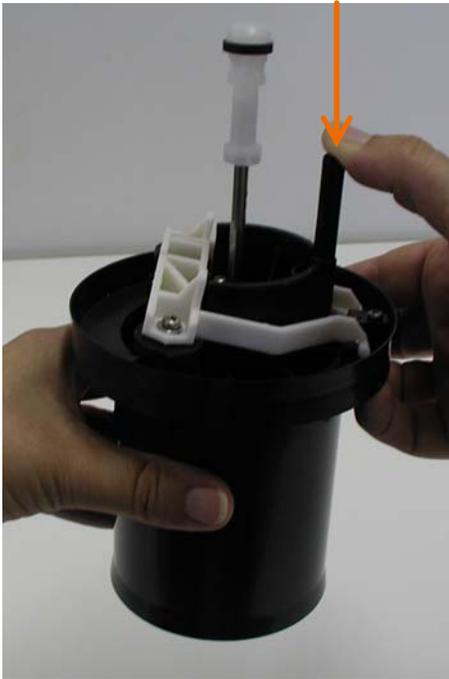
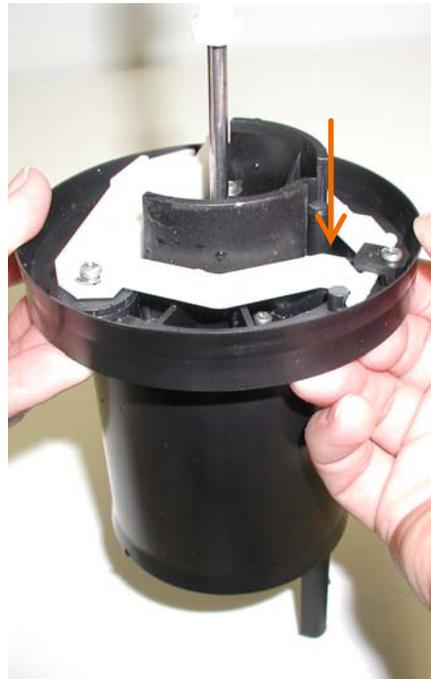
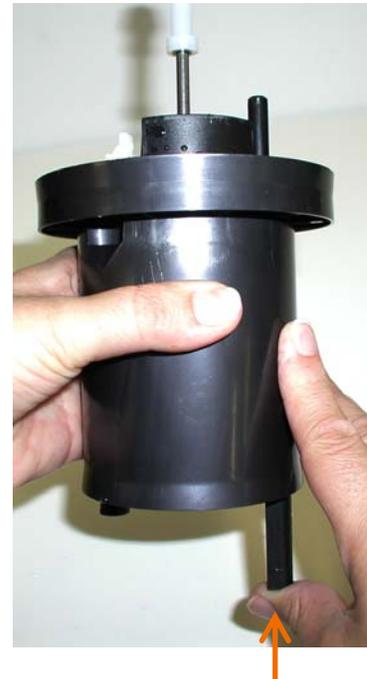
Reset D45 Series Piston

To reset the piston, remove the piston from the housing. Holding the piston, push down on the vertical rod all the way down it may click.

Push the vertical rod all the way up, it should click. Push the vertical rod all the way down once more and it should click.

| Symptom | Cause | Solution |
|--|--|--|
| | Piston locked up/not clicking | Reset piston. See instructions |
| No suction of solution | Piston locked up/not clicking | Reset piston. See instructions |

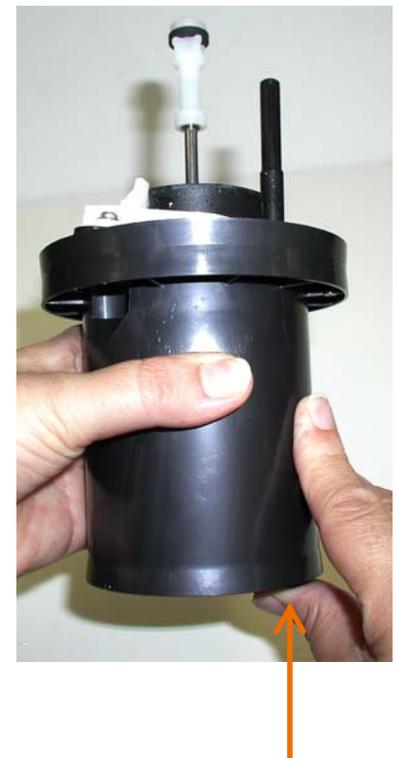
Caution during reassembly:

Carefully insert the piston assembly into the upper housing first and push it all the way in. Be aware that dents in the shell flange will affect performance. Without bending the plunger rod, slide lower housing over piston assembly until the lower and the upper housing meet. Make sure the housing O-ring is in place. Insert and thread the housing lock nut, until tight.
